# Building Condition Report

| Property address: | <b>Your Address</b> |
| Building type: | <b>Office</b> |

| Report number: | <b>UK1234</b> |

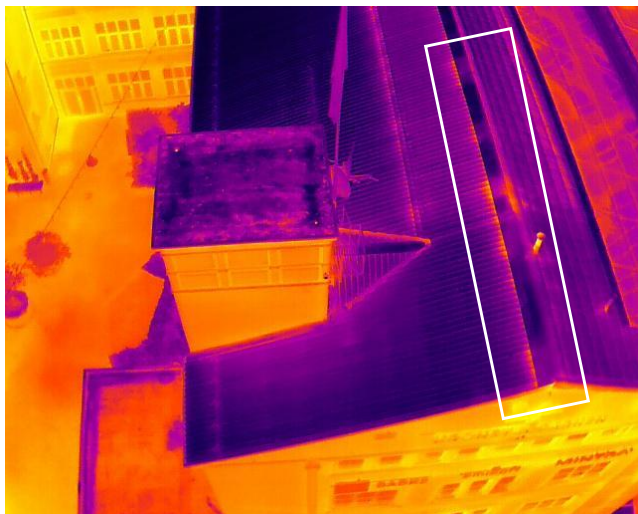
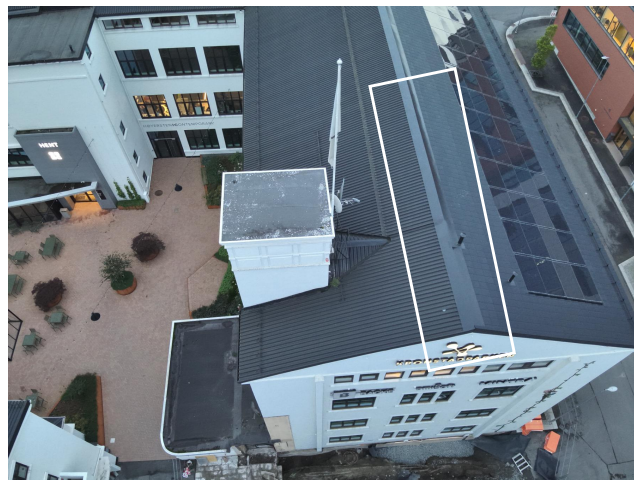
## Deviation 001 – Roof

RPL 3

Heat loss has been identified in the marked thermogram, indicating a thermal anomaly in the roof section. This suggests the presence of a thermal bridge, where heat is escaping through areas of insufficient insulation. The observable evidence from the thermogram highlights the specific locations where the temperature differential is significant. The extent of the issue appears to be localized, but it may have implications for overall energy efficiency and comfort within the building. The affected areas should be closely monitored for further signs of heat loss or moisture intrusion. Visual inspection may reveal additional clues regarding the integrity of the insulation in these regions.

The most likely cause of the heat loss is inadequate insulation at the thermal bridge locations. This can lead to increased energy consumption and potential discomfort for occupants. If left unaddressed, it may also result in moisture problems, which could compromise the building's structural integrity over time.

kWh: 390    CO<sub>2</sub> (kg): 48.3

Improve insulation in the identified areas to mitigate heat loss. Conduct regular inspections to ensure the effectiveness of the insulation. Consider implementing preventative measures to avoid future thermal bridging.

| Deviation | Section | Issue | Recommended action |
|---|---|---|---|
| <b>001</b> | Roof | The most likely cause of the heat loss is inadequate insulation at... | Improve insulation in the identified areas to mitigate heat loss |

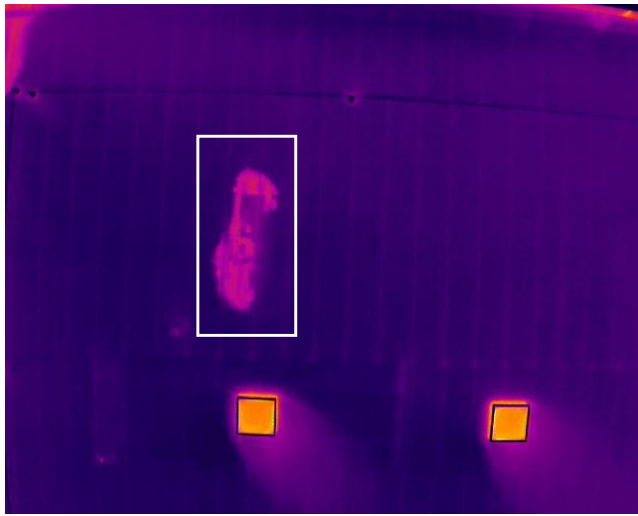
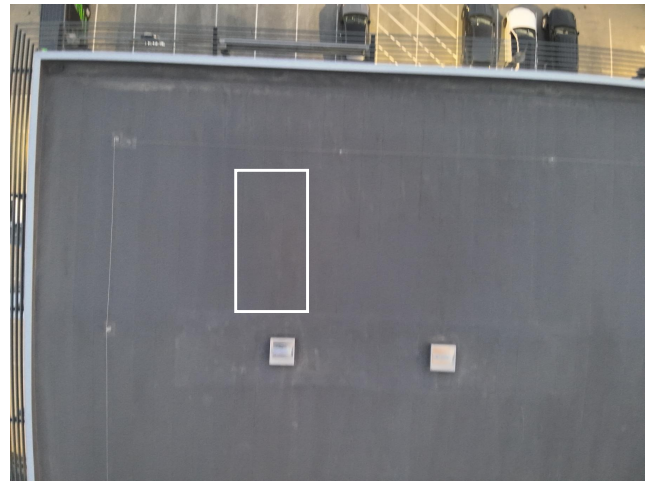
## Deviation 002 – Roof

RPL 3

Significant moisture accumulation has been detected beneath the roofing membrane, as evidenced by the attached thermal image. The affected area is located on the roof, where the insulation is likely compromised due to the presence of water. This condition poses a risk of further damage to the roofing structure and insulation materials. The extent of the moisture accumulation suggests a prolonged exposure to water, which could lead to mold growth and deterioration of building materials. Immediate attention is required to assess the full impact of this moisture intrusion.

The most likely cause of the moisture accumulation is a breach in the roofing membrane, allowing water infiltration. This can lead to significant risks, including structural damage, insulation failure, and potential health hazards due to mold growth. The uncertainty surrounding the extent of the damage necessitates a thorough investigation.

kWh: 412    CO<sub>2</sub> (kg): 82

Remove the wet insulation to prevent further damage. Repair the hole in the roofing membrane to stop water infiltration. Implement regular inspections to prevent future occurrences.

| Deviation | Section | Issue | Recommended action |
|---|---|---|---|
| <b>002</b> | Roof | The most likely cause of the moisture accumulation is a breach in... | Remove the wet insulation to prevent further damage |

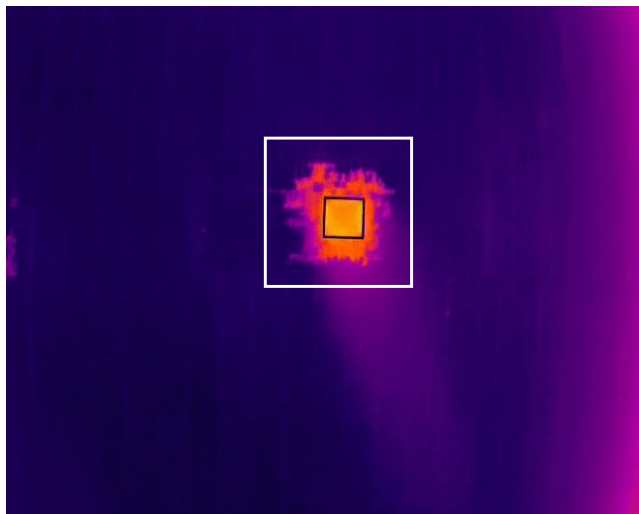
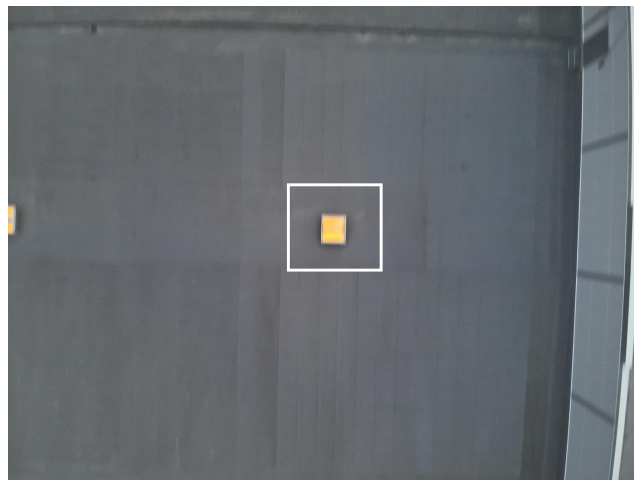
## Deviation 003 – Roof

RPL 3

There are significant challenges with condensation within the roof structure, as evidenced by the thermal imaging results. The issue is not visually apparent but is indicated by the thermal anomalies detected. Poor insulation around the skylight has been identified as a contributing factor to the condensation problem. The affected area includes the roof membrane and surrounding insulation, which may be compromised due to moisture accumulation. This situation suggests a potential risk of further damage to the roofing system if not addressed promptly. The extent of the problem requires careful evaluation to determine the full impact on the structural integrity of the roof.

The primary cause of the condensation is likely inadequate insulation around the skylight, leading to temperature differentials that promote moisture accumulation. If left unaddressed, this could result in mold growth, deterioration of building materials, and potential structural damage over time. The uncertainty lies in the extent of moisture penetration and its long-term effects on the roof structure.

kWh: 390    CO<sub>2</sub> (kg): 78

Remove the wet insulation and repair the affected areas. Re-roof the membrane to ensure proper sealing and insulation. Implement measures to improve insulation around the skylight.

| Deviation | Section | Issue | Recommended action |
|---|---|---|---|
| <b>003</b> | Roof | The primary cause of the condensation is likely inadequate insulation around the... | Remove the wet insulation and repair the affected areas |

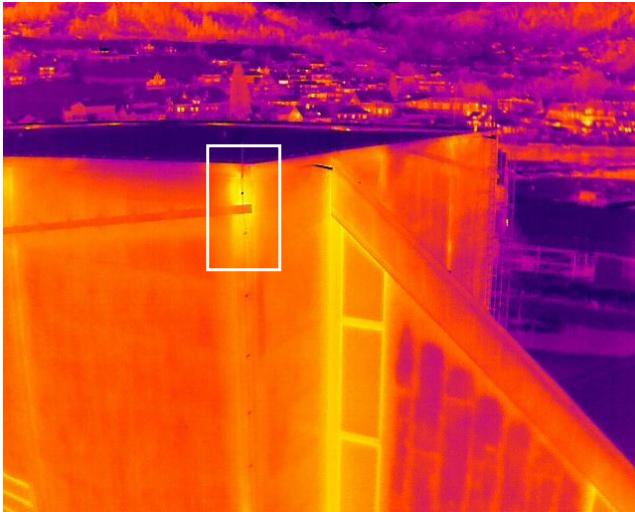
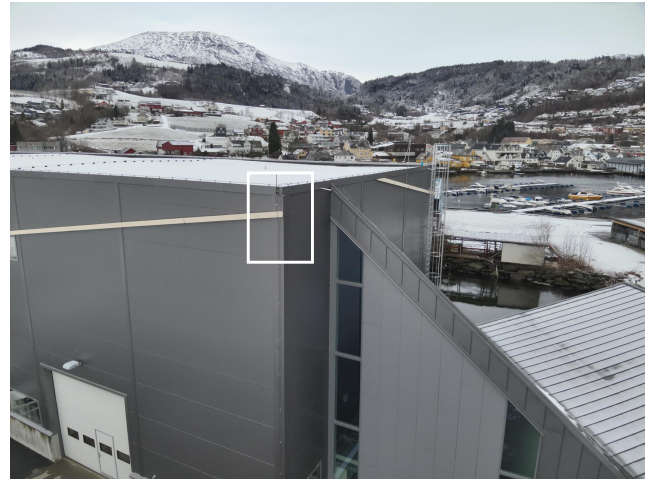
## Deviation 004 – Facade

RPL 2

A clear thermal bridge is evident in the marked area of the thermal image, although it is not visually observable. This indicates a potential issue with heat loss in the facade. Additionally, there is poor sealing observed at the outer corner, which may lead to condensation within the construction. The extent of the issue suggests that it could affect the overall thermal performance of the building. The thermal imaging highlights the discrepancy in temperature, indicating a significant deviation from expected thermal behavior. This could compromise the integrity of the building envelope over time.

The likely cause of the thermal bridge is inadequate insulation or a break in the thermal barrier at the marked location. Poor sealing at the outer corner exacerbates this issue, increasing the risk of moisture ingress and potential condensation within the structure. If left unaddressed, these conditions could lead to mold growth and deterioration of building materials.

kWh: 270    CO<sub>2</sub> (kg): 53,7

Dismantle the external cladding to access the affected area. Repair the sealing at the outer corner to prevent further moisture intrusion. Ensure proper insulation is reinstated to mitigate thermal bridging.

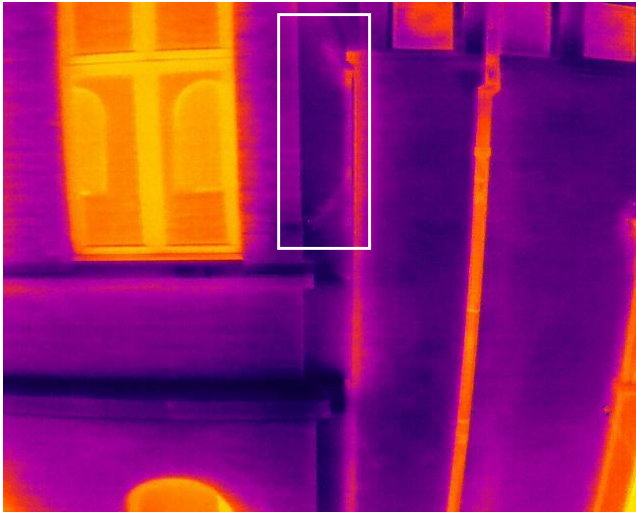
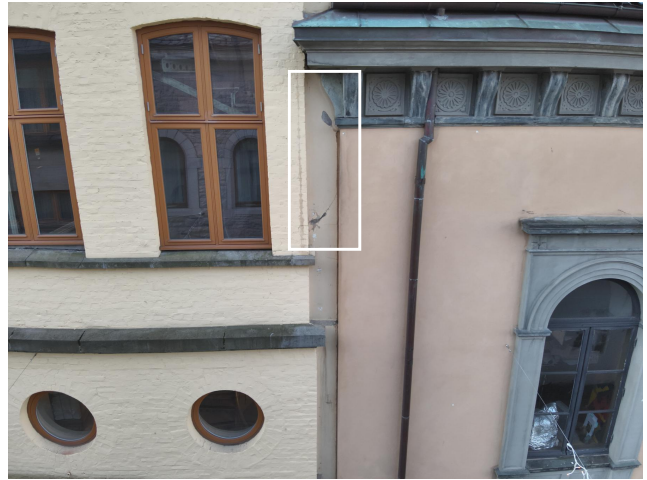
## Deviation 005 – Facade

RPL 3

Cracking has been observed in the facade, which is evident both thermally and visually. The cracks appear to be distributed across various sections of the facade, indicating a potential structural issue. The extent of the cracking suggests that it may be significant, warranting further investigation. The visual evidence shows irregular patterns of cracking that could compromise the integrity of the building. Thermal imaging may reveal temperature differentials associated with the cracks, suggesting underlying issues. The facade's condition raises concerns about its long-term durability and performance.

The exact cause of the cracking is uncertain, but it is likely related to settlement damage. Such damage can occur due to ground movement or inadequate foundation support. If left unaddressed, these cracks could lead to further structural deterioration and potential safety hazards.

Repairs should be conducted promptly to address the cracking in the facade. A thorough assessment of the foundation and surrounding soil conditions is recommended. Preventative measures should be implemented to mitigate future settlement issues.

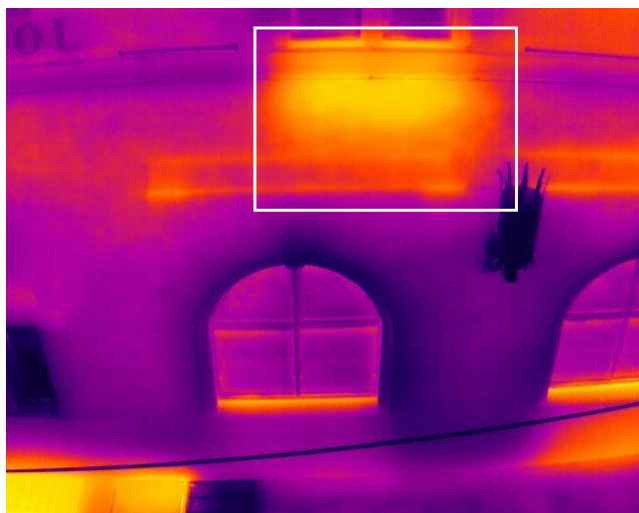
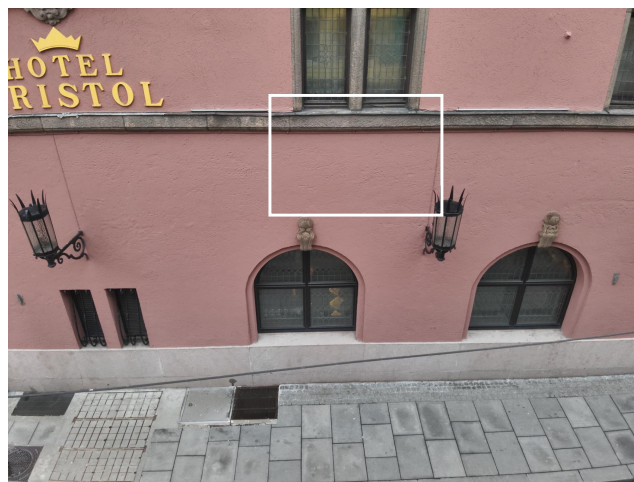
## Deviation 006 – Facade

RPL 2

Significant thermal bridging is observed at the base of the window, as evidenced by the marked thermal image indicating heat loss. This issue is primarily located where the window frame meets the adjacent construction. The extent of the thermal bridging suggests a considerable energy loss, which may impact the overall energy efficiency of the building. The insulation layer between the window frame and the adjoining structure is either limited or entirely absent, exacerbating the thermal inefficiency. This condition can lead to increased heating costs and potential discomfort for occupants due to drafts.

The most likely cause of this issue is inadequate or missing insulation at the junction between the window frame and the surrounding construction. This lack of proper insulation can result in significant energy loss and may lead to condensation issues, which could further damage the building fabric over time. Uncertainty exists regarding the full extent of the insulation deficiency without further investigation.

kWh: 1400    CO<sub>2</sub> (kg): 279

Repair the seal under the window to improve insulation. Ensure that proper insulation is installed between the window frame and adjacent construction. Regularly inspect and maintain window seals to prevent future issues.

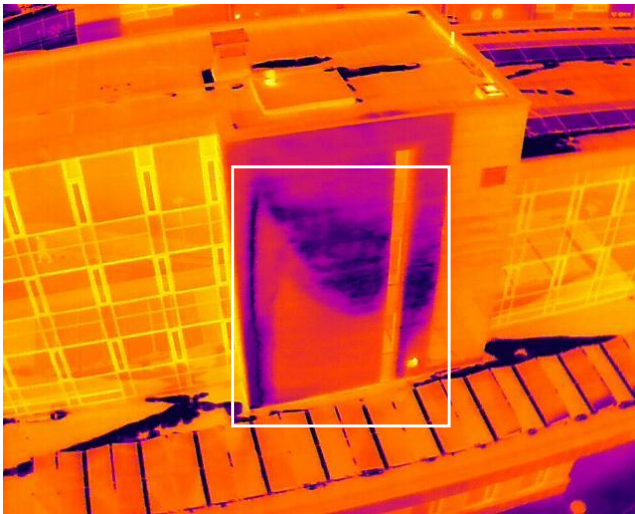
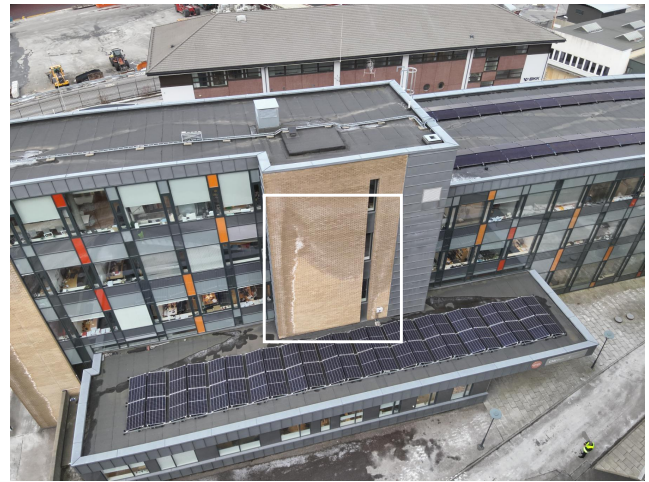
## Deviation 007 – Facade

RPL 3

Significant moisture retention has been observed in the construction, which is evident as darker areas in the attached thermal image. This moisture issue appears to be widespread, affecting various sections of the facade. The extent of the moisture infiltration suggests a potential underlying problem that requires further investigation. The affected areas are likely to compromise the integrity of the building materials and may lead to further deterioration if not addressed promptly. The presence of moisture can also create an environment conducive to mold growth, posing health risks to occupants. A thorough assessment is necessary to determine the full extent of the damage and the specific locations impacted.

The most likely cause of the moisture retention is a leak from the roof or parapet, which has allowed water to infiltrate the facade. This situation poses risks such as structural damage, mold growth, and potential health hazards for building occupants. The uncertainty regarding the exact source of the leak necessitates a detailed investigation to confirm the cause and extent of the moisture problem.

Conduct a thorough inspection to identify the source of the leak. Implement necessary repairs to the roof or parapet to prevent further moisture intrusion. Monitor the affected areas for any signs of recurring moisture issues.

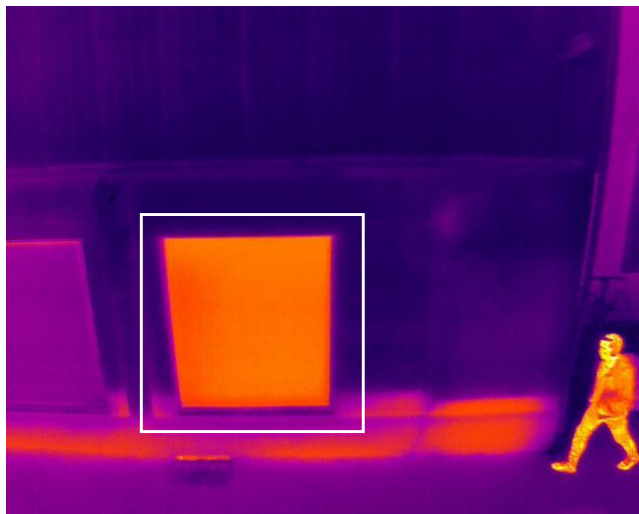
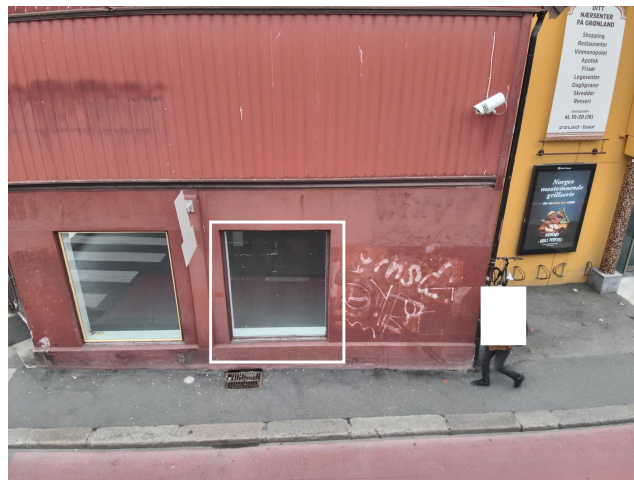
## Deviation 008 – Facade

RPL 2

The marked window exhibits clear signs of puncturing, which is visible upon inspection. This defect is characterized by the presence of air leakage between the glass layers, leading to a compromised thermal performance of the window. The issue is localized to the specific window indicated, and it affects the overall energy efficiency of the facade. The visual evidence suggests that the integrity of the window's seal has been breached, which may also lead to condensation or fogging between the panes. This condition can significantly impact the comfort and energy consumption of the building. The extent of the problem appears to be limited to this particular window, but it may indicate broader issues if not addressed promptly.

The primary cause of the observed issue is likely due to a failure in the sealant or the glass itself, resulting in puncturing. This failure can lead to increased air infiltration, which negatively affects the window's U-value and overall energy efficiency. If left unaddressed, this could result in further deterioration of the window and increased energy costs for heating or cooling. There is some uncertainty regarding whether the damage is isolated or indicative of a more systemic problem within the facade.

kWh: 1150    CO<sub>2</sub> (kg): 229

The window should be repaired or replaced to restore its integrity and thermal performance. Regular inspections of window seals and glass should be conducted to prevent similar issues in the future.

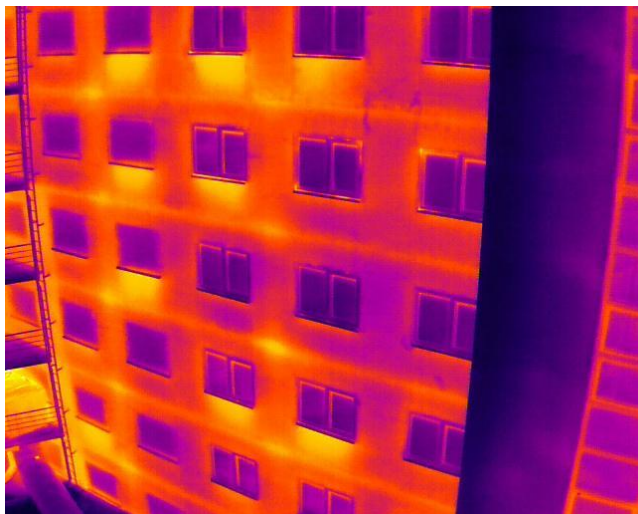
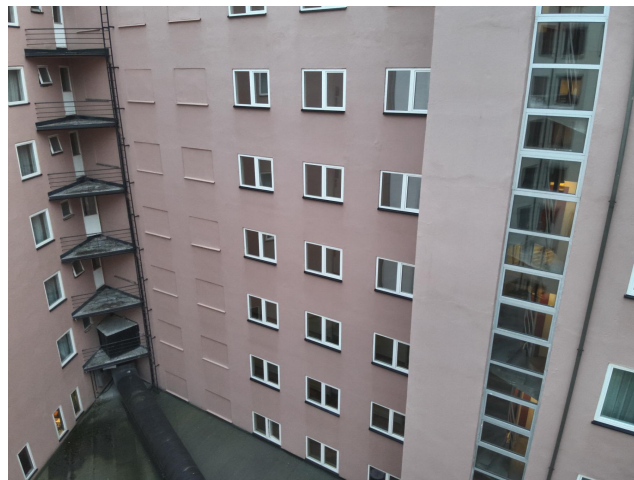
## Deviation 009 – Facade

RPL 2

Significant heat loss is observed from all windows in the marked facade. The heat loss is primarily prominent at the bottom of the windows. This condition leads to considerable energy loss and condensation, which adversely affects the condition of both the windows and the surrounding construction. The issue is particularly noticeable in the lower sections of the window frames. Visual inspection reveals gaps and potential signs of moisture accumulation. The extent of the problem suggests a systemic issue with the window installations.

The likely cause of the heat loss is poor or missing sealing and insulation between the bottom frame of the windows and the surrounding construction. This deficiency can lead to increased energy costs and potential structural damage over time due to moisture infiltration and condensation.

kWh: 18300    CO<sub>2</sub> (kg): 3641

Improve the sealing by adding insulation or foam between the window frames. Ensure that all gaps are properly filled to prevent future heat loss. Regular maintenance checks should be implemented to monitor the condition of the seals.
